# FE295 WIRE DRAG

## DESCRIPTIVE REPORT

Type of Survey .. Wire Drag .....

Sublocality ..... Approaches to Aransas Pass .....

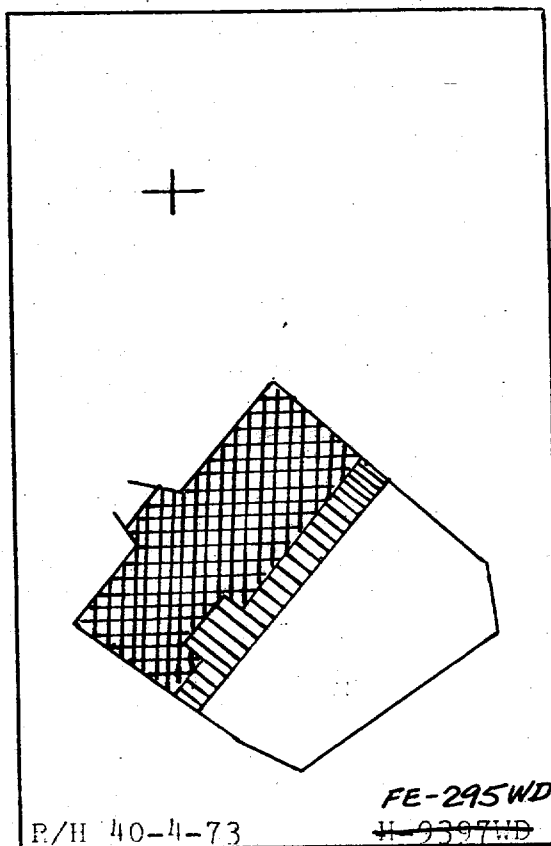
Progress Sketch

## - REPRESENTS AREA COMPLETED  
IN SEPTEMBER

||| - REPRESENTS AREA COMPLETED

IN OCTOBER
